FIELD INVESTIGATION PHOTOGRAPH ALBUM

**OPERABLE UNIT NO. 1
(SITES 21, 24, AND 78)**

**MARINE CORPS BASE, CAMP LEJEUNE
NORTH CAROLINA**

JANUARY 27, 1995

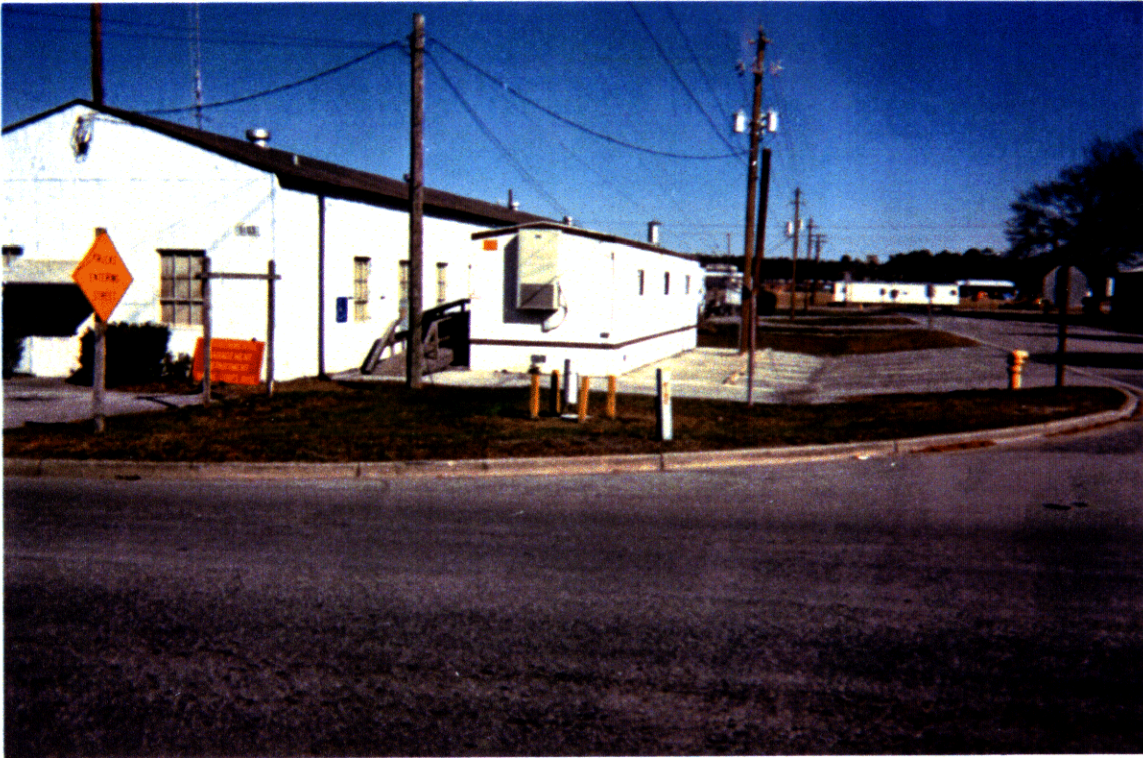
OU1.Site78.1993.01 Building 1103 at HPIA. Monitoring well in foreground. Once used for paint storage.

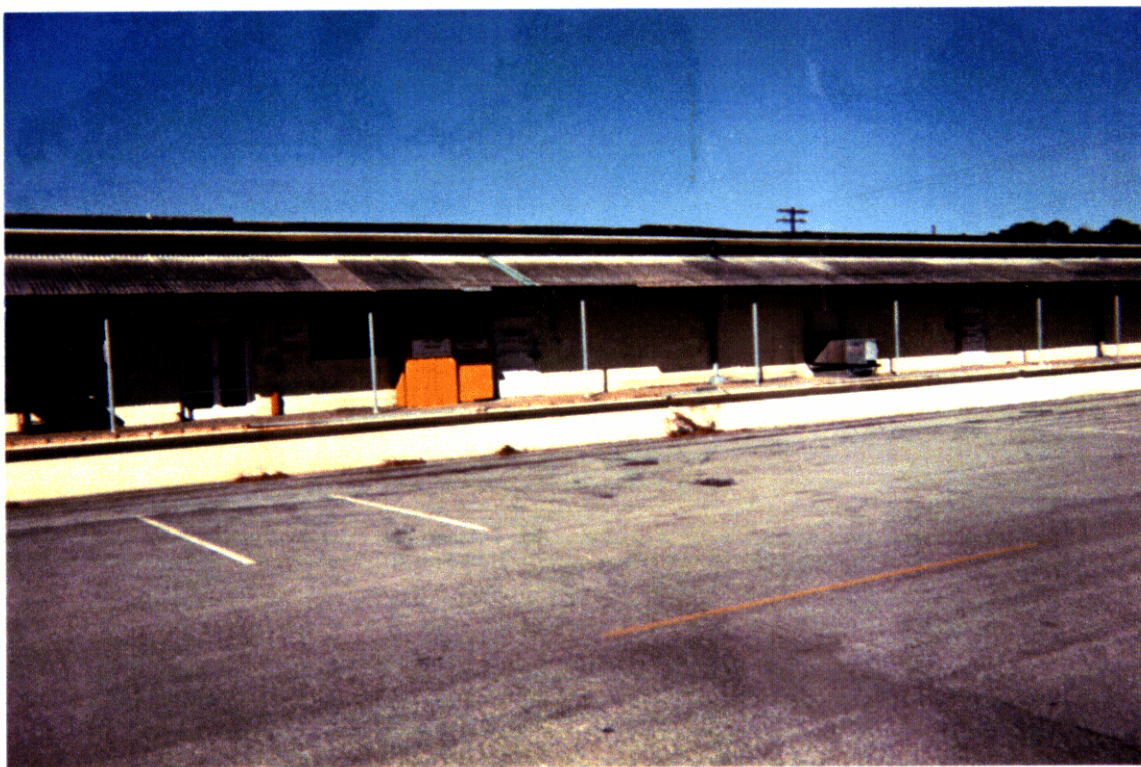
OU1.Site78.1993.02 Building 1300 at HPIA. Monitoring well in foreground. Identified as a refrigeration maintenance shop. Also used for solvent storage.

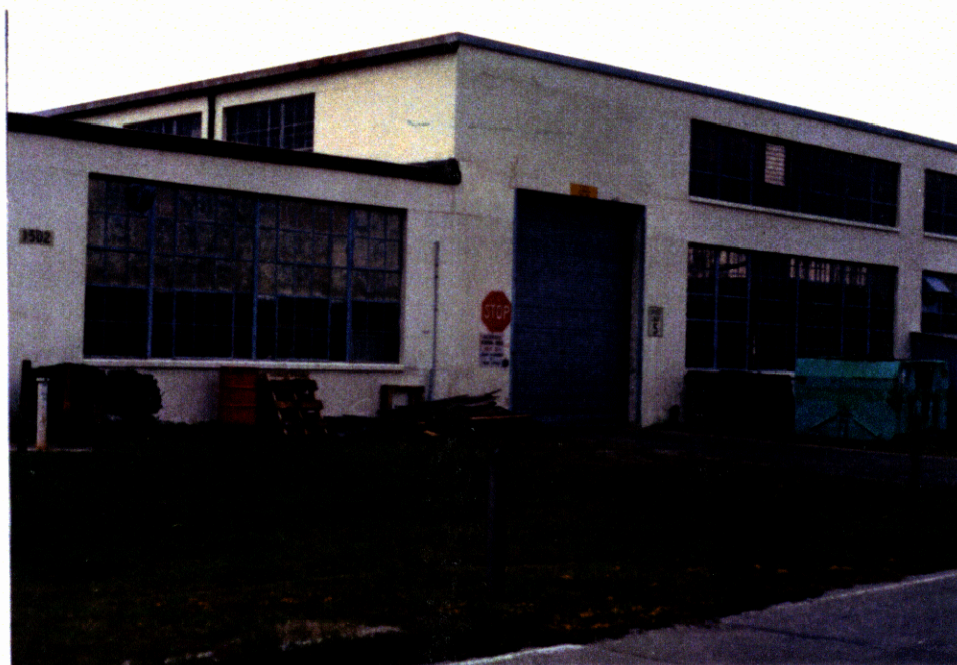
OU1.Site78.1993.03 Building 1502 at HPIA along Elm Street. Underground Storage Tanks discovered in this area. Monitoring well to the left.

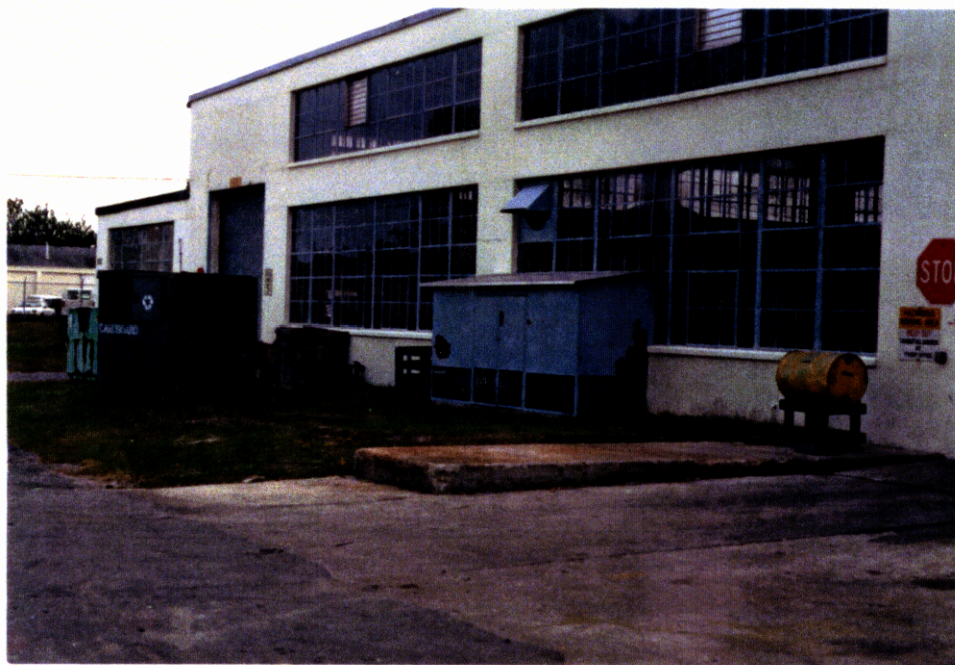
OU1.Site78.1993.04 Building 1502 at HPIA along Elm Street. Pesticides were identified in the grassy area shown.

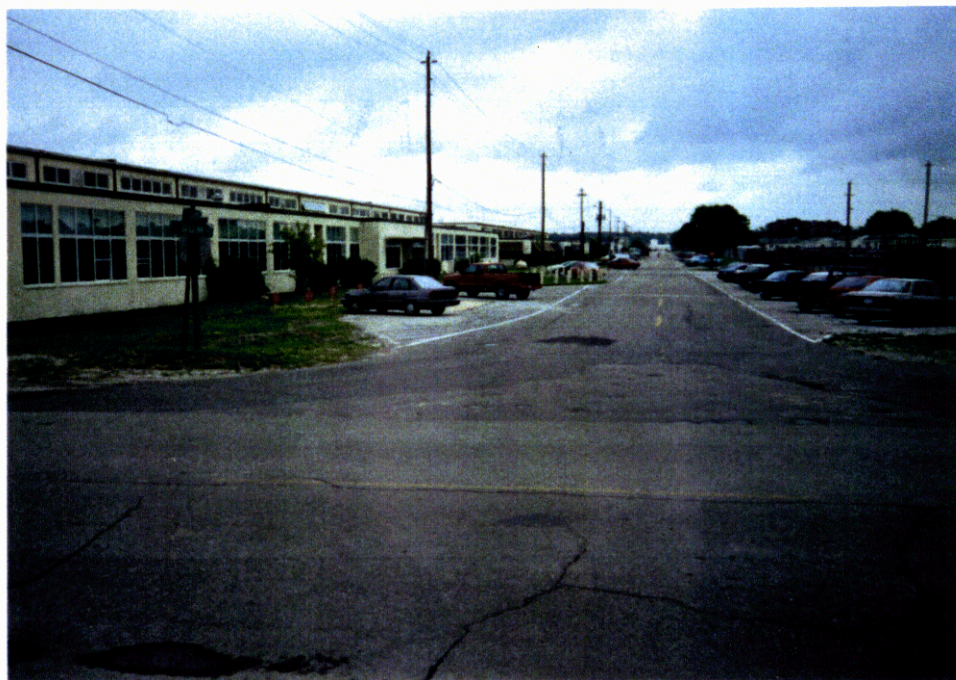
OU1.Site78.1993.05 Corner of Gum Street and East Road at HPIA. Building 1601 on left; Building 1502 on the far left. These are UST areas.

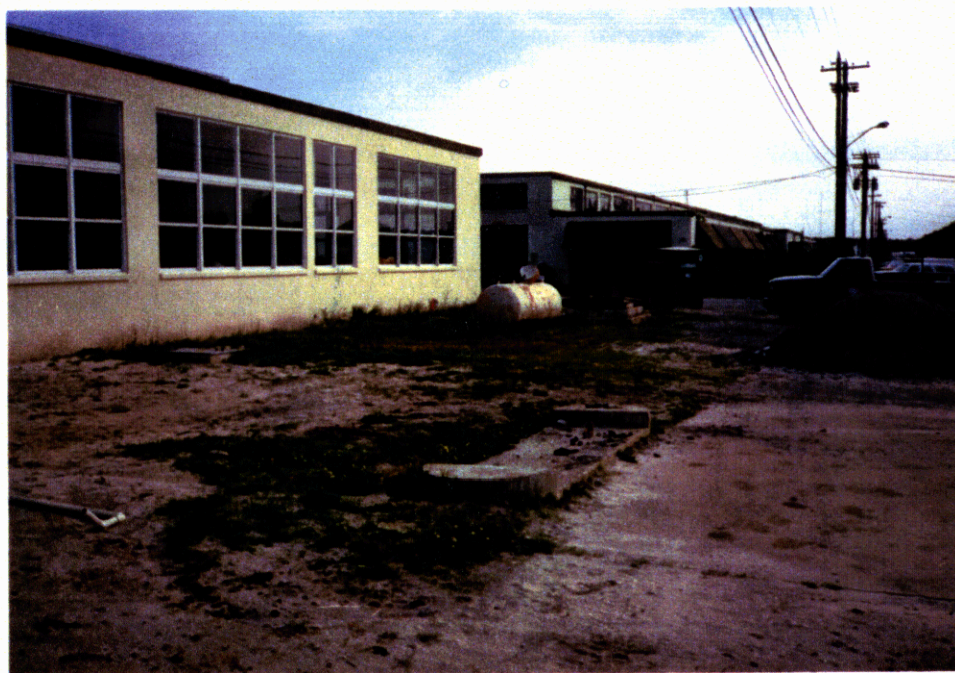
OU1.Site78.1993.06 Closeup of Buildings 1601 and 1502. Areas of concern due to USTs and significant solvent use.

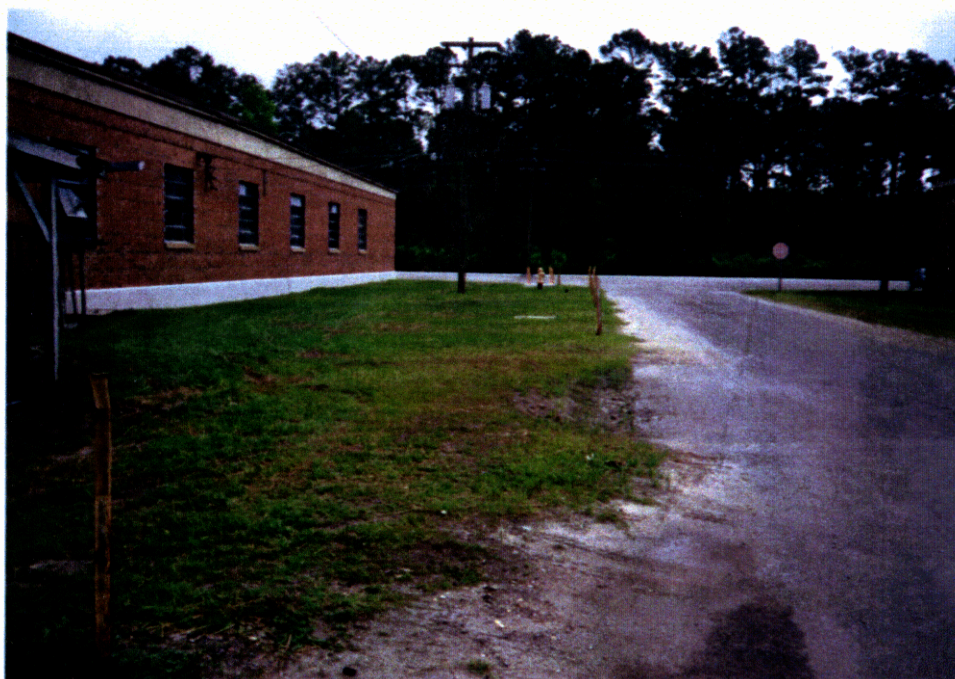
OU1.Site78.1993.07 UST area at HPIA. Buildings 901, 902, and 903. Significant solvent (TCE) use at this area.

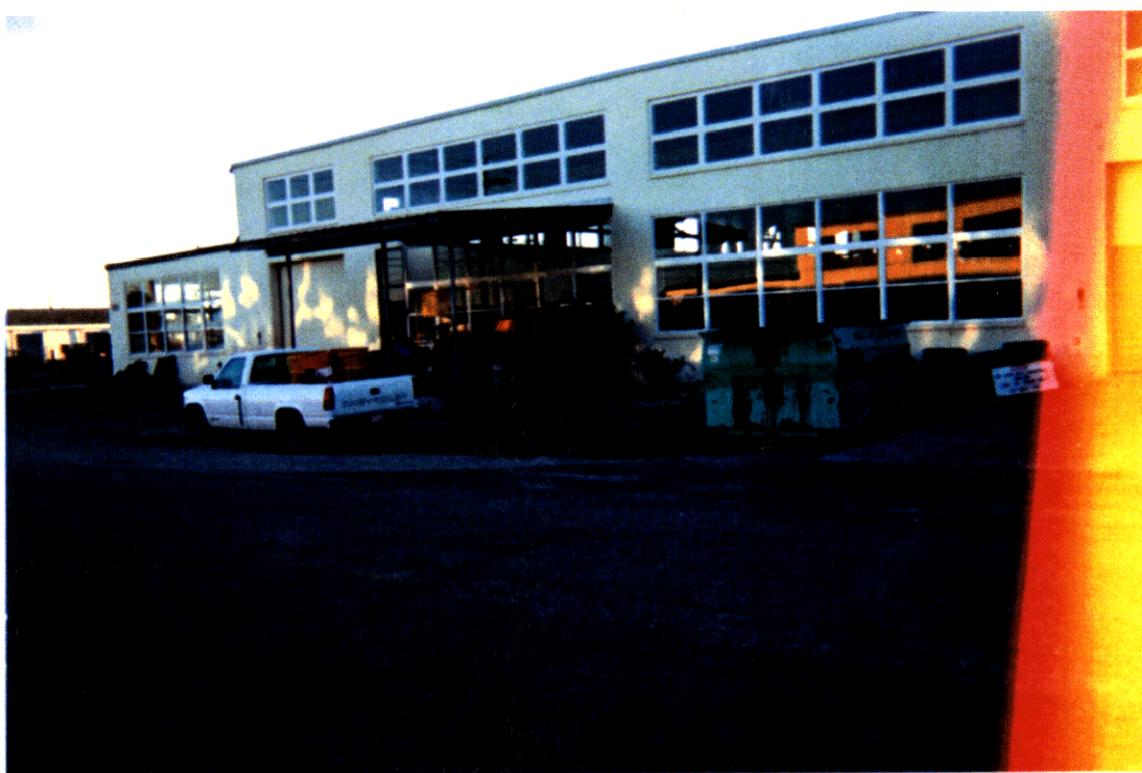
OU1.Site78.1993.08 Northern end of Building 160 along Fir Street. Used for maintenance. Has inactive USTs.

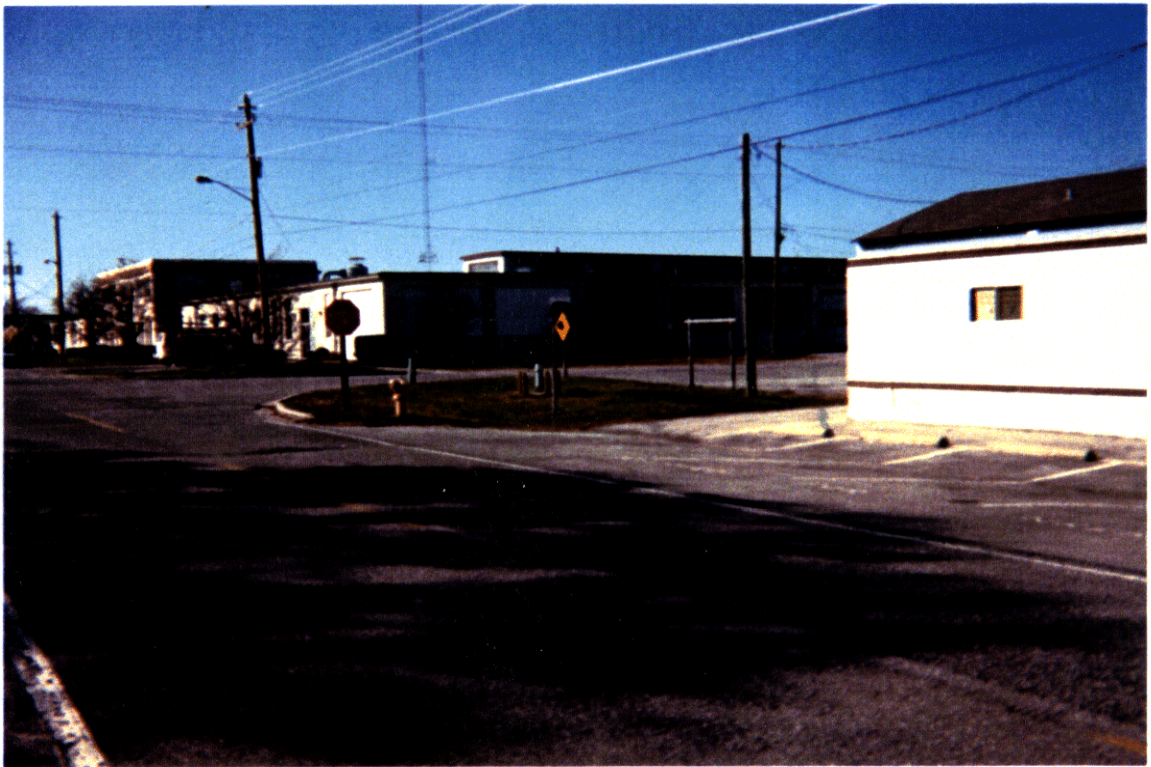
OU1.Site78.1993.09 Typical HPIA buildings along East Road (corner of Building 1103, Building 1202 in rear).

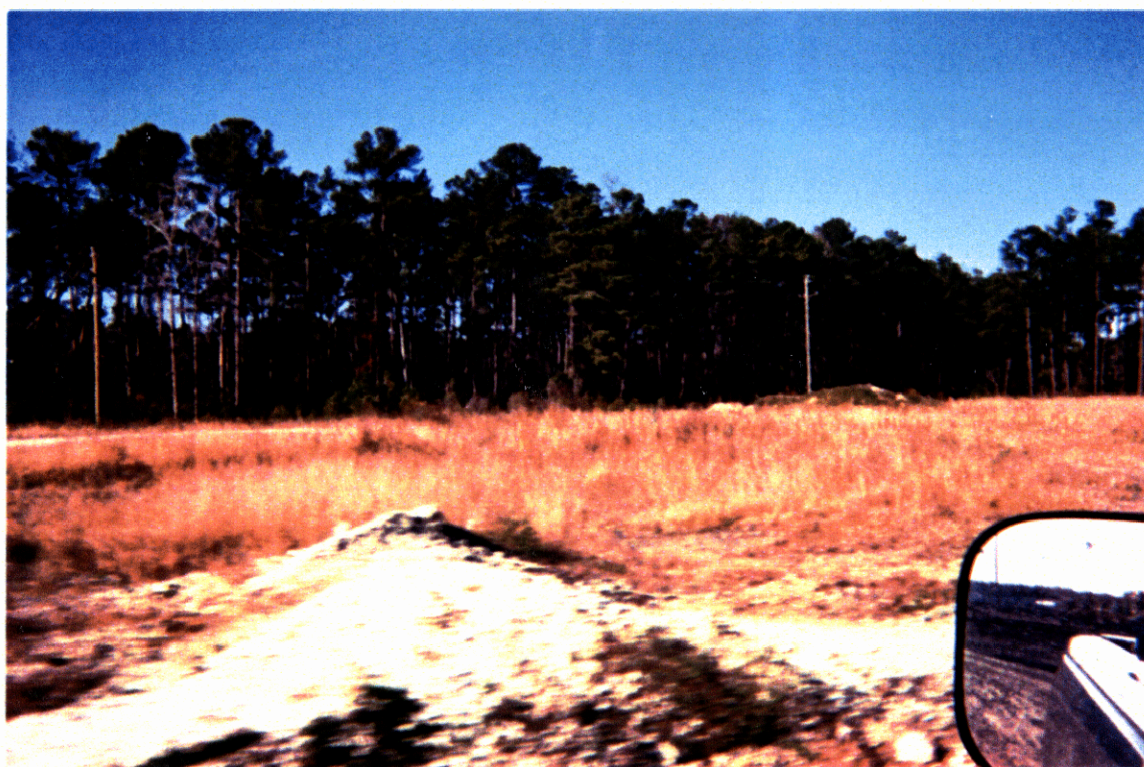
OU1.Site21.1993.01 Northern portion of Site 21 where the Former Transformer Disposal Area was reportedly located.

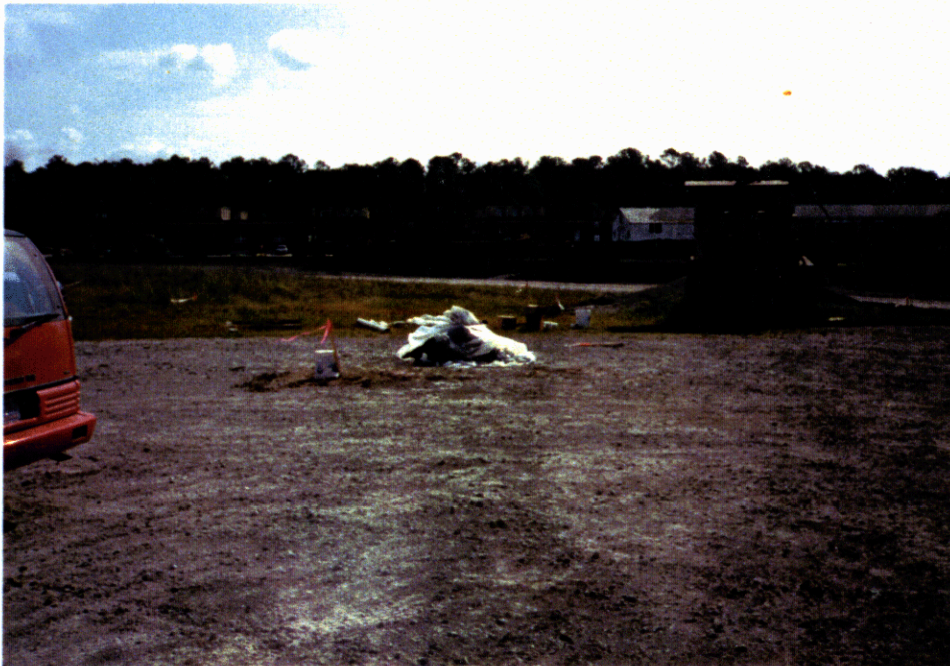
OU1.Site21.1993.02 Northern portion of Site 21 where the Former Transformer Disposal Area was reportedly located. Sampling location is marked by a stake wrapped with flagging tape.

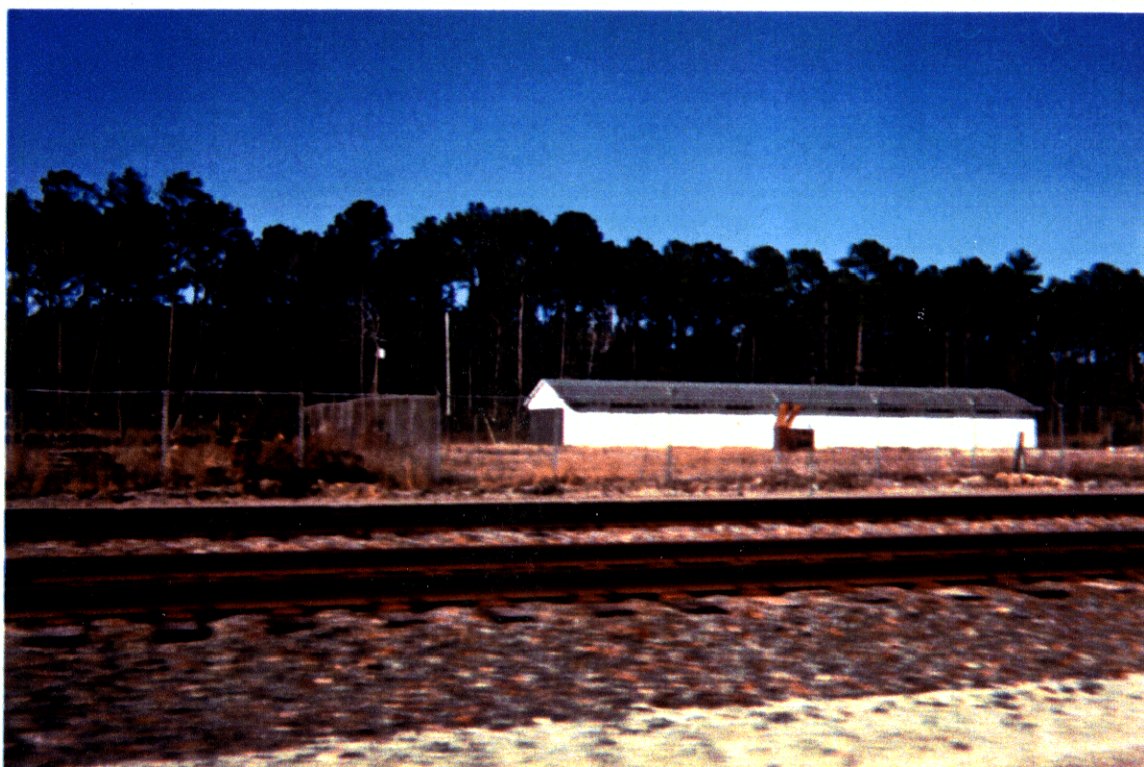
OU1.Site21.1993.03 Middle portion of Site 21. Area includes Building 1014 which had been used for paint storage.

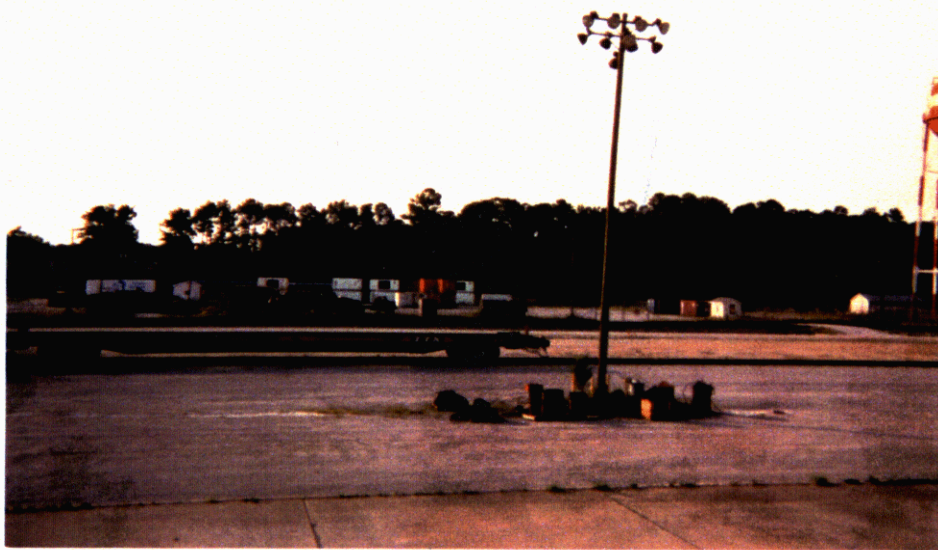
OU1.Site21.1993.04 View of southern half of Site 21; site area is between the trees in the back and the fenceline behind the railroad tracks. The water tower is within the site.

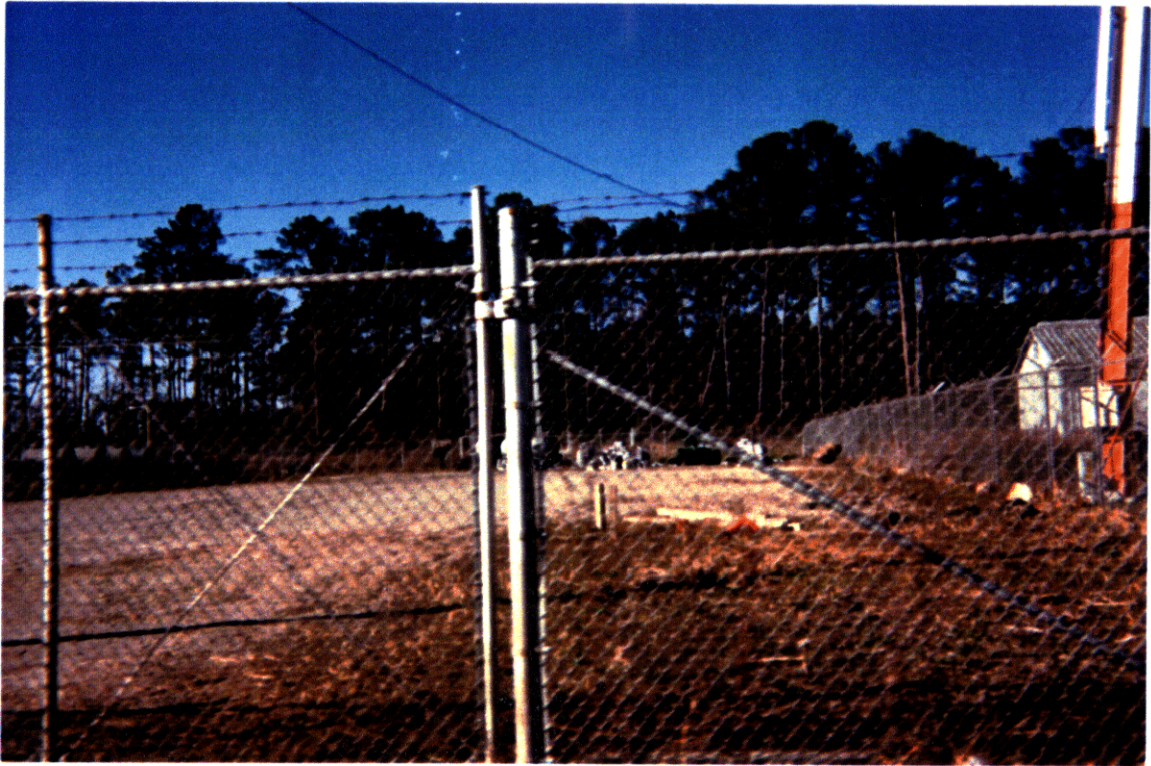
OU1.Site21.1993.05 Closeup view of the fenced in area southwest of the water tower and Building 1013. Potential pesticide mixing/wash area.

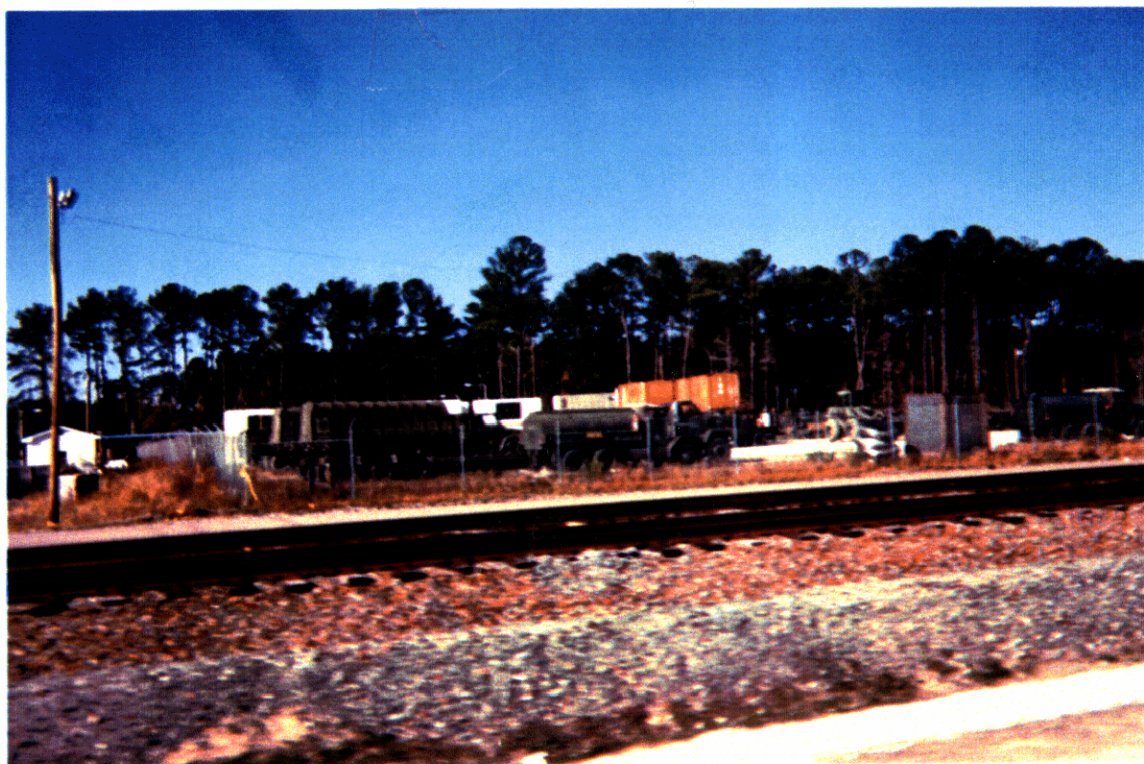
OU1.Site21.1993.06 Southern-most fenced-in area of Lot 140. Currently used for storage of vehicles and other items. Suspected pesticide contaminated area.

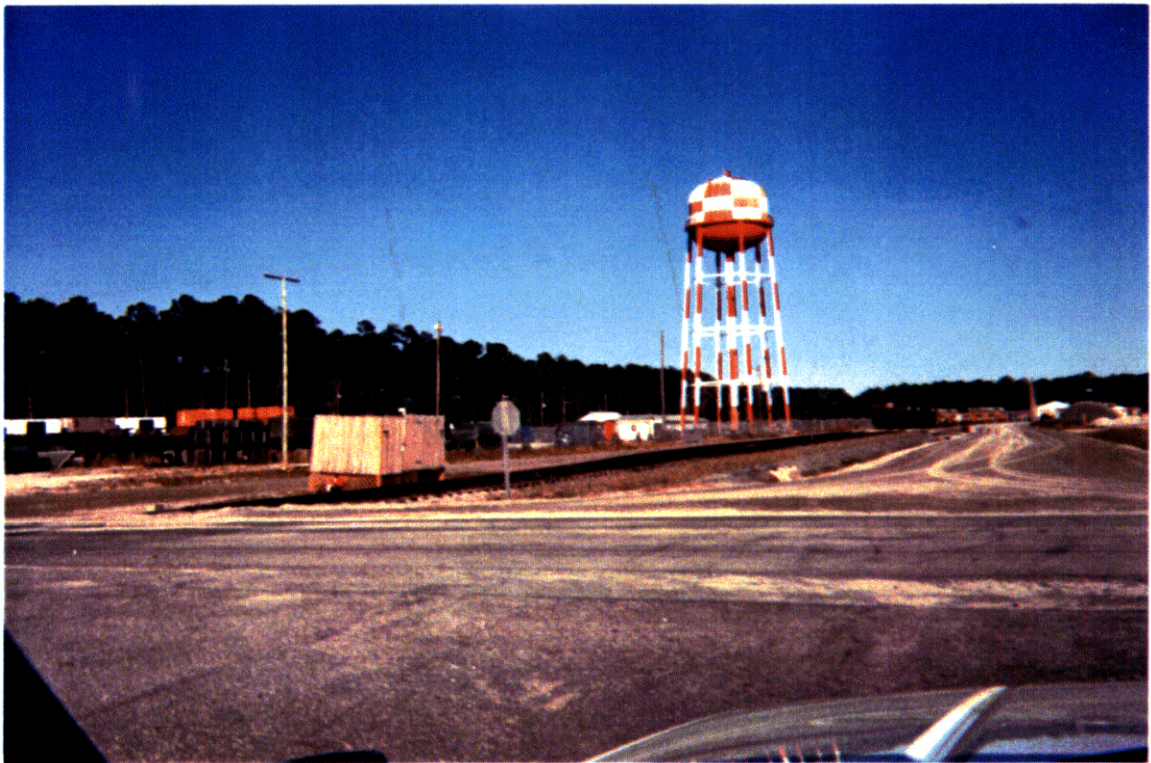
OU1.Site21.1993.07 Southeast portion of Lot 140 (left of the railroad tracks). Area believed to be the location of the pesticide mixing and pesticide equipment cleaning area.

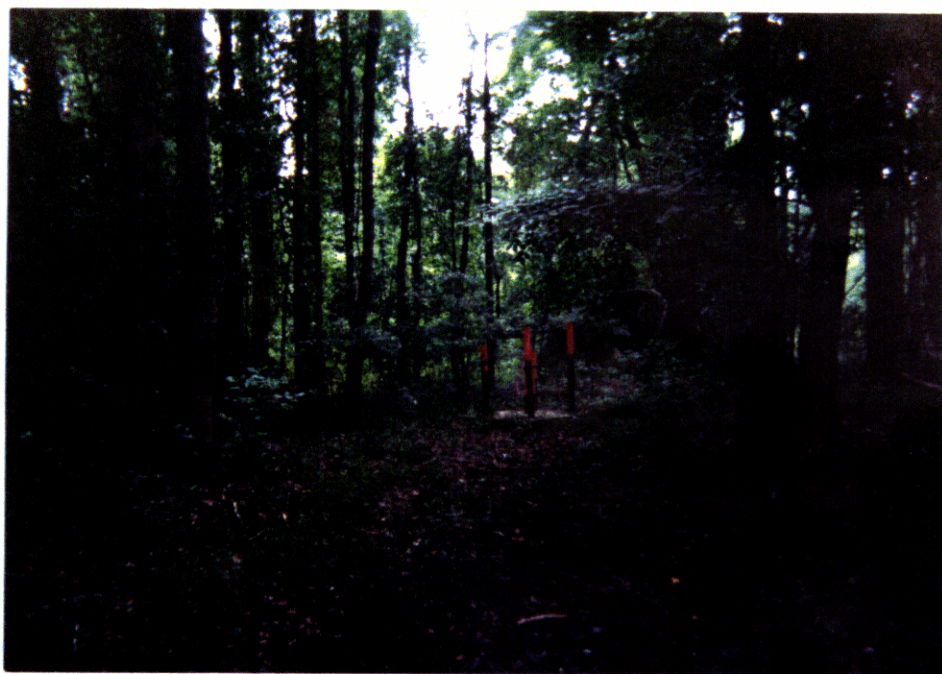
OU1.Site24.1993.01 Newly installed monitoring well in center of this area of Site 24.

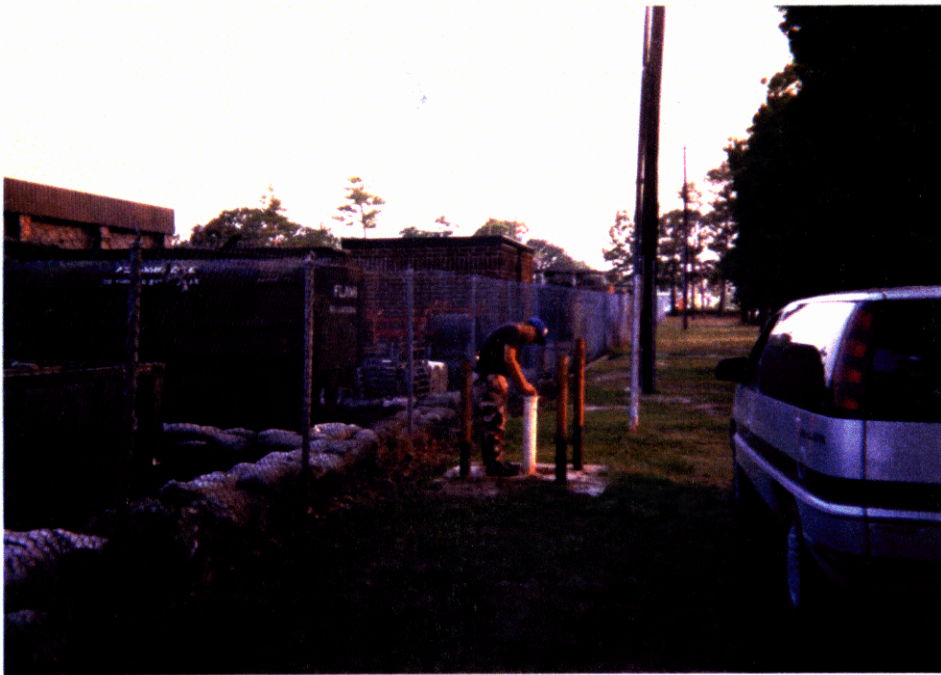
OU1.Site24.1993.02 Baker personnel unlocking outer casing of monitoring well at Site 24 prior to groundwater sampling.

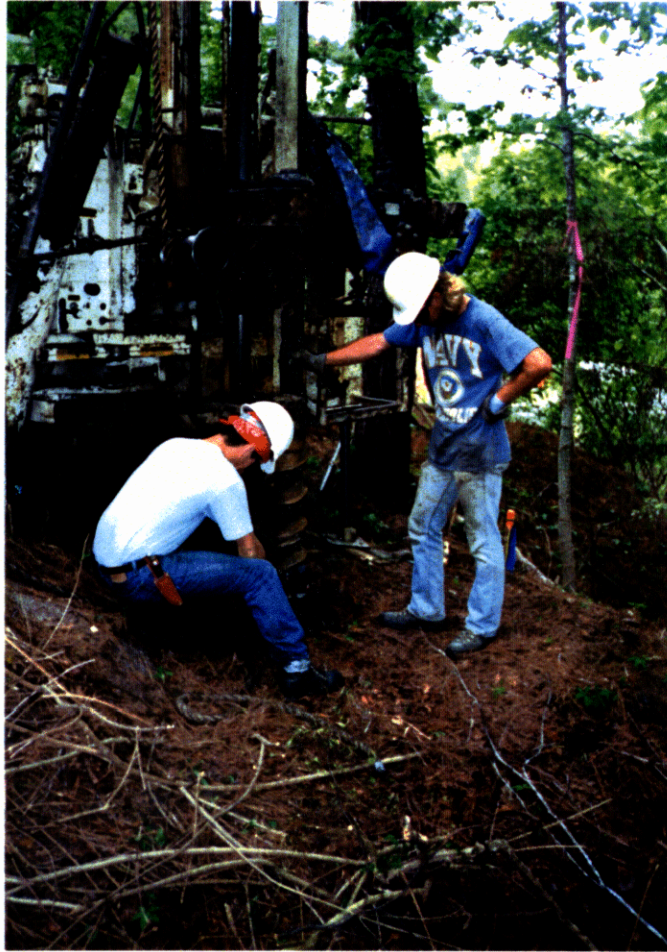
OU1.GW.1993.01 Field crew advancing a boring. Crew member on the left is monitoring the borehole with an HNu for health and safety.

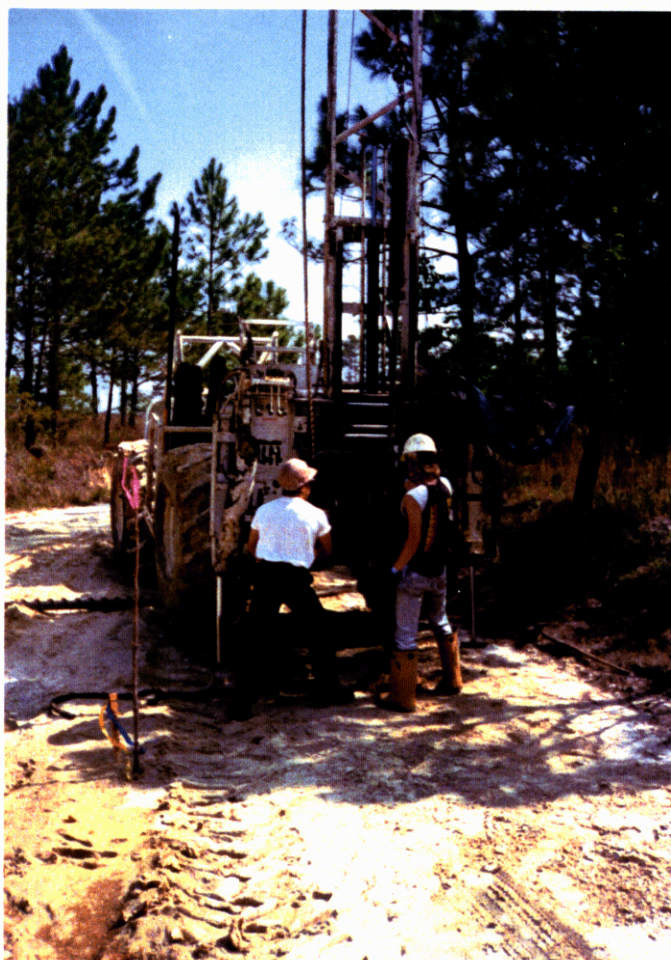
OU1.GW.1993.02 Rod with the split spoon sampler being raised from the borehole.

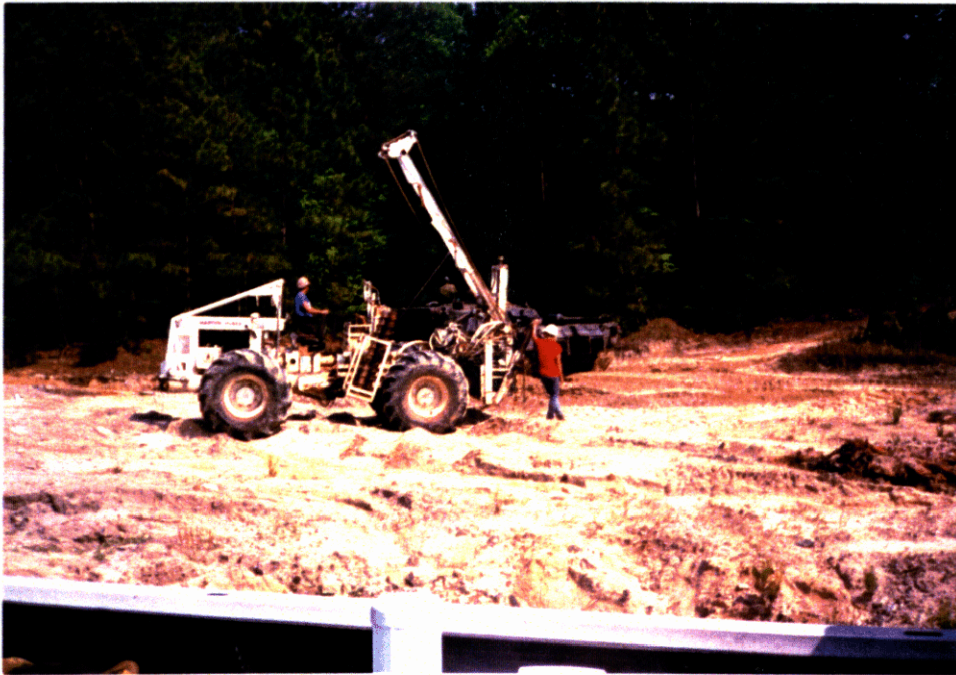
OU1.GW.1993.03 Mobile All Terrain Vehicle drilling rig setting up.

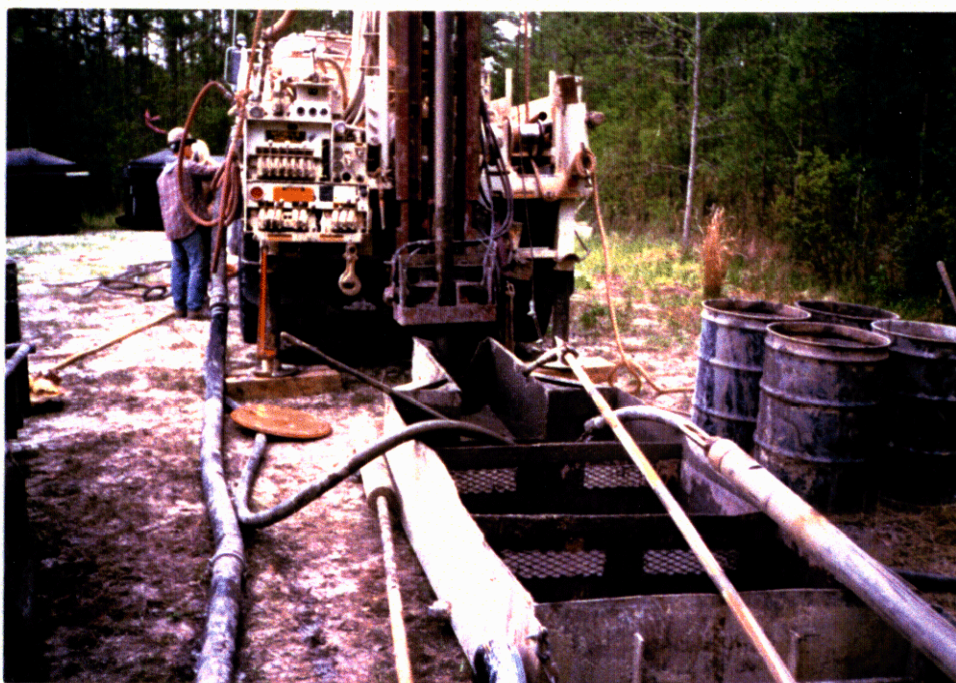
OU1.GW.1993.04 Mud rotary drilling set up.

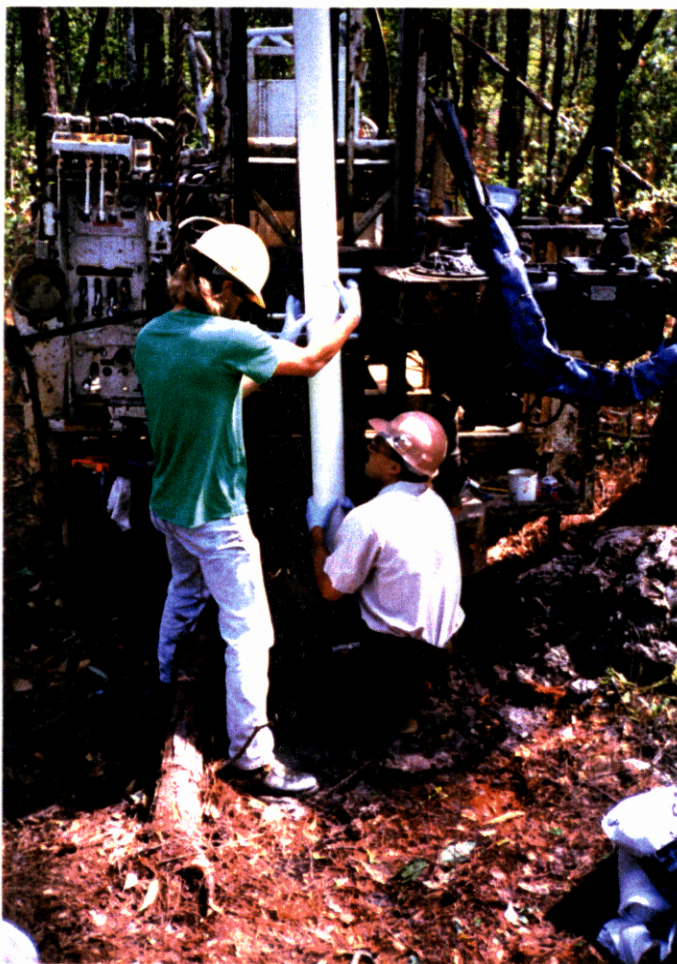
OU1.GW.1993.05 Field personnel installing PVC pipe for monitoring well.

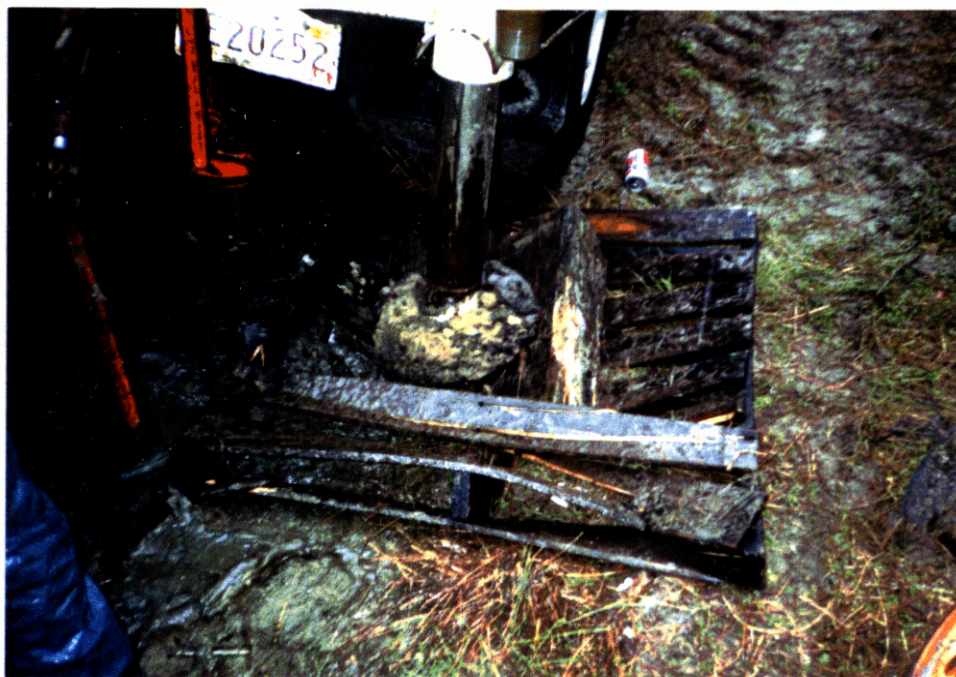
OU1.GW.1993.06

View of truck mounted drill, and casing installation.

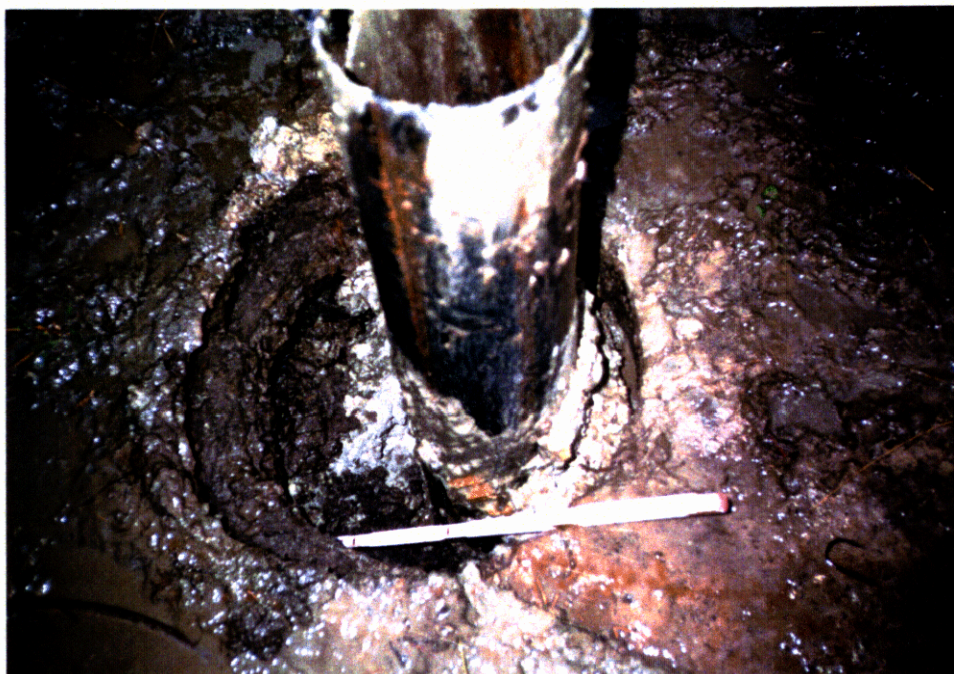
OU1.GW.1993.07

Closeup of borehole and casing installation. Grout/bentonite mixture filling up space between casing and borehole wall.

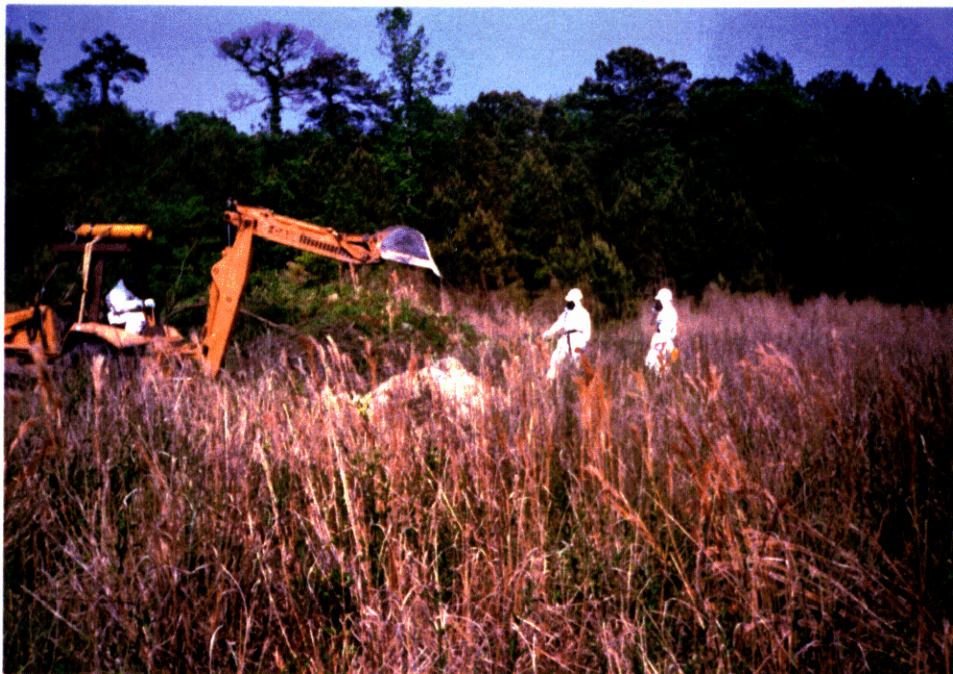
OU1.SL.1993.01

Test pit operations performed as an exploratory excavation to assess the contents of past disposal burial operations. Investigation conducted in "Level B" health and safety protective gear.

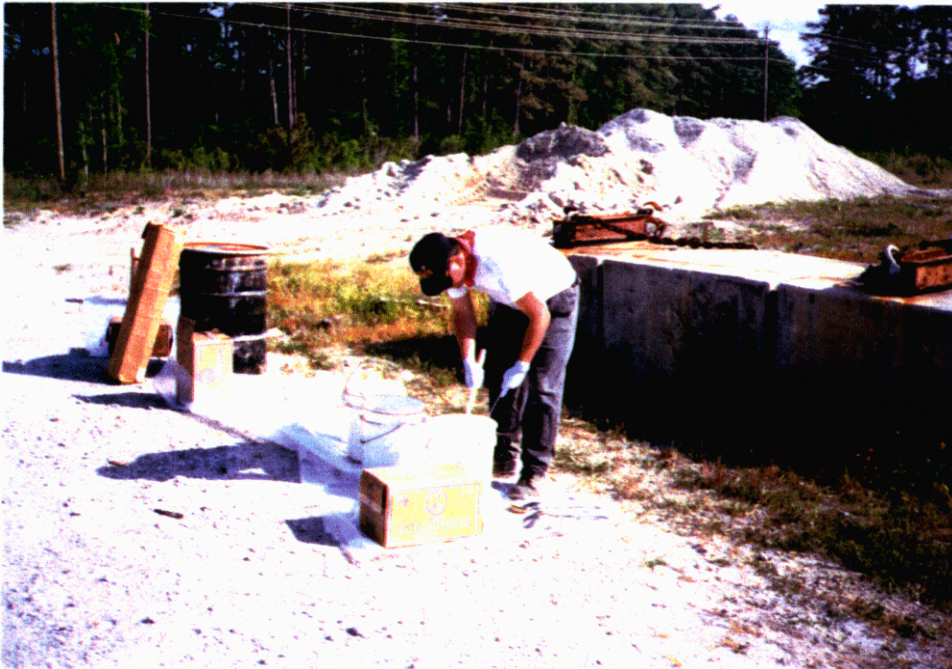
OUI.SL.1993.02

Field personal decontaminating soil sampling equipment.

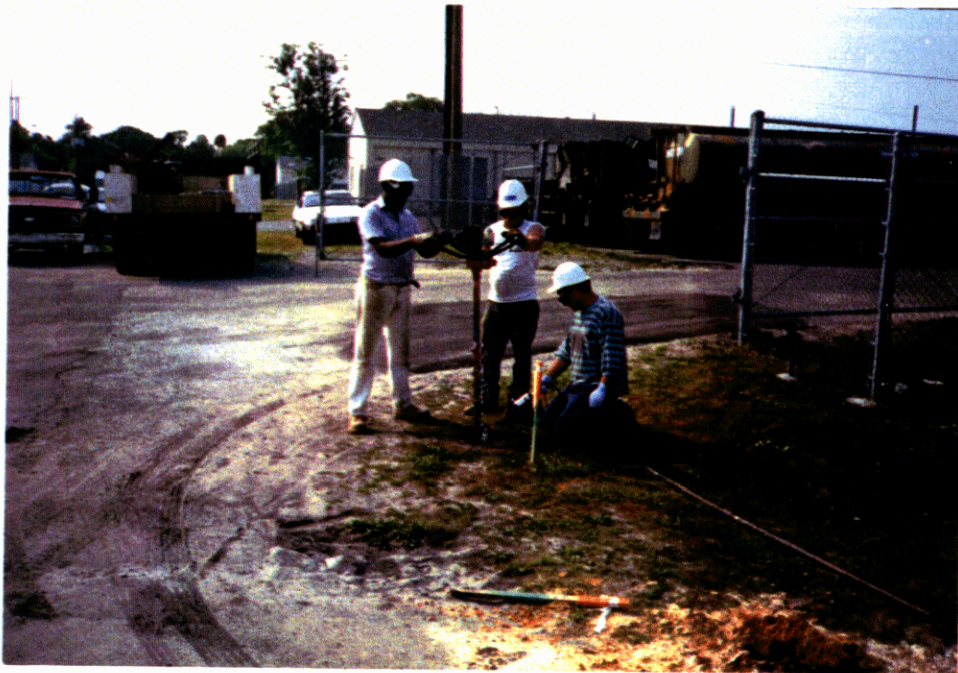
OU1.SL.1993.03

Field personnel collecting subsurface soil samples at suspected **UST** area.
